Vulnerability Assessment of Flash Floods within Buea Municipality Using Field and Remote Sensing Techniques: Case of the 2020 flash flood

BLANCHE NABILA DOHNJI¹, MABEL NECHIA WANTIM^{1*}, KULU ERIC NDIVE¹, ASONG FRED ZISUH¹

Department of Environmental Science
University of Buea,
P.O. Box 63, Buea
CAMEROON

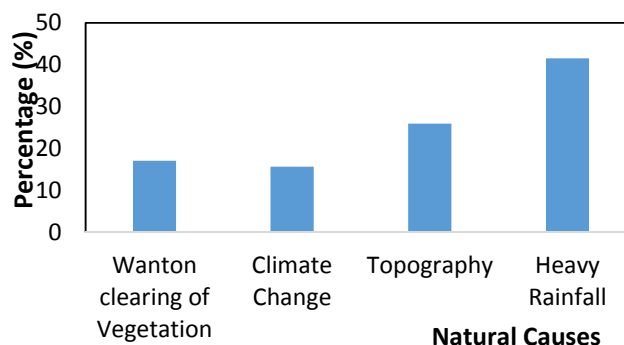
Fig.3: Plot showing the natural factors which are believed to be responsible for flash floods in Buea Municipality

Findings from this study as per the respondents revealed that the natural causes responsible for flash floods in Buea Municipality were: heavy rainfall (41.5 %), topography (25.9 %), wanton clearing of vegetation (17 %) and climate change (15.6 %) (Fig. 3). Heavy rainfall is believed to play a significant role in flash flood occurrence in Buea municipality due to the fact that the March 2020 flash flood occurred after a period of intense rainfall, same with the recent March 2023 flash floods. This points to the fact that these flash floods are associated with heavy rainfalls, characterized with low percolation and infiltration rates arising from poor drainages and lack of vegetation cover in the area.

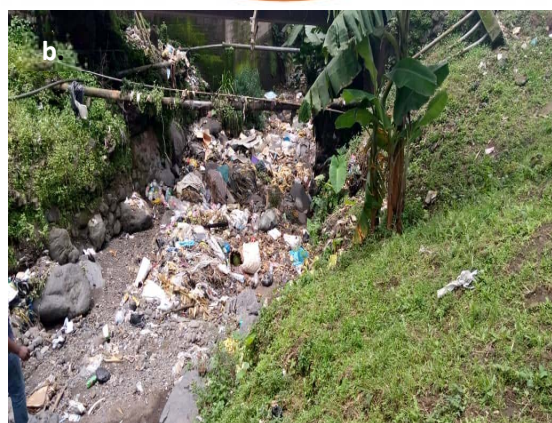
Fig.4: Anthropogenic causes of flash floods represented on: **a.** pie chart and **b.** photograph showing poor waste disposal within a water channel in Bakweri Town (a locality in Buea)

The two main anthropogenic causes of flash floods in the municipality as cited by the respondents were: poor waste disposal practices (57 %) and unsustainable building practices (43 %) (Fig.4a&b).

Anthropogenic causes of the 2020 flash floods in Buea municipality based on questionnaire analyses, were linked to poor waste disposal practices and unsustainable building practices. Poor waste disposal practices cause flash floods through blocking of water paths and raising of the water path floor ([17]. The population in Buea municipality has significantly increased (~ 500,000 people now from 130,000 in 2010; [26]) in the last two decades linked to the creation of the University of Buea and other higher institutions of learning and the ongoing civil strife in Anglophone Cameroon. Increased population means increased waste with limited facilities to handle the waste [17]. The municipality has very narrow drainages. The act of constantly cleaning these drainages without creating bigger channels, does not help the situation. This result conforms to that of [40], who reported that poor drainages and uncontrolled dumping of household waste amongst other material greatly enhance flash floods.

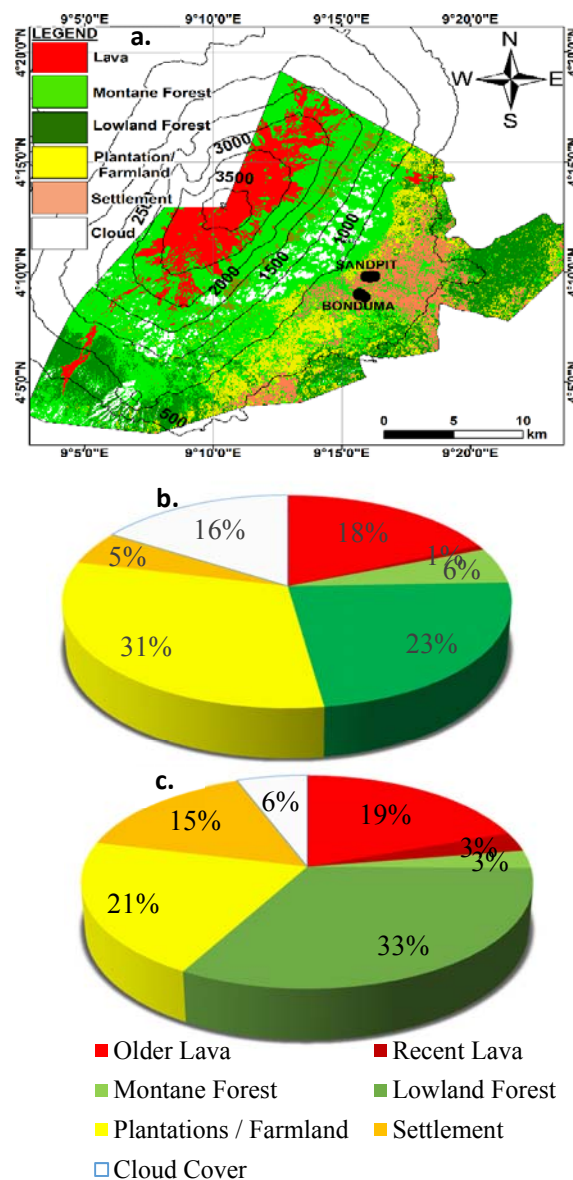
Fig.5. Illustrations showing: **a.** supervised classified image of 2018 showing the different land covers in the Buea Municipality in 2018; **b & c.** total surface areas (%) covered by the different land covers in Buea Municipality in 1986 and 2018 respectively.

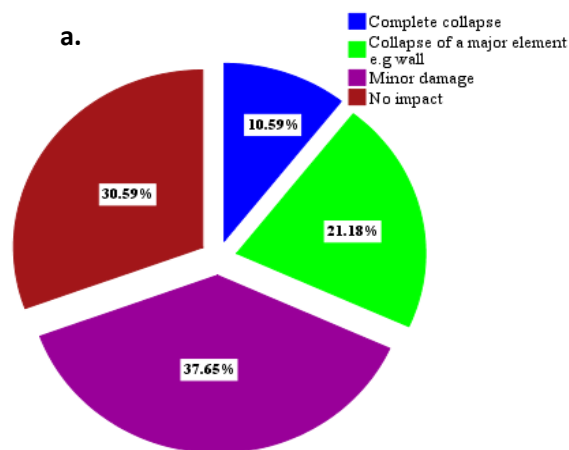
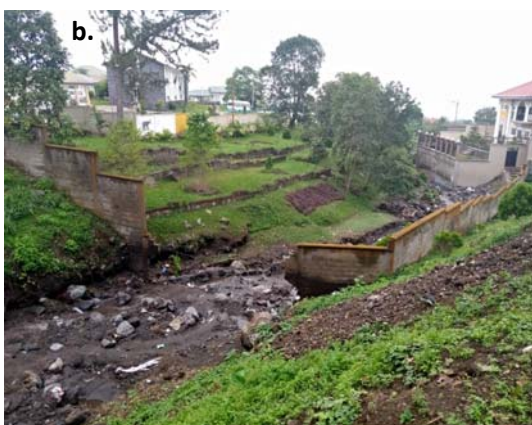
Fig.6. Physical impact of the 2020 flash floods on buildings represented on: **a.** pie chart and **b.** damaged wall at Federal Quarters (Mountain Hotel Area)

Taking the case study of the 2020 flash floods and the impact it had on buildings; 37.65 % of the respondents cited that they incurred minor damages to their houses; while 10.59 % registered complete damage (Fig. 6). In terms of other losses caused by the 2020 flash floods, 25 % mentioned agricultural losses; 15 % mentioned the death of animals; 35 % mentioned the loss of household items; while <5% mentioned the loss of human life.
